Richard B. Russell Dam and Lake

Final Foundation Report Volume 2 of 2

US Army Corps
of Engineers
Savannah District

RICHARD B. RUSSELL PROJECT
SAVANNAH RIVER, GEORGIA AND SOUTH CAROLINA
FINAL FOUNDATION REPORT
CONCRETE DAM, EMBANKMENTS, AND POWERHOUSE

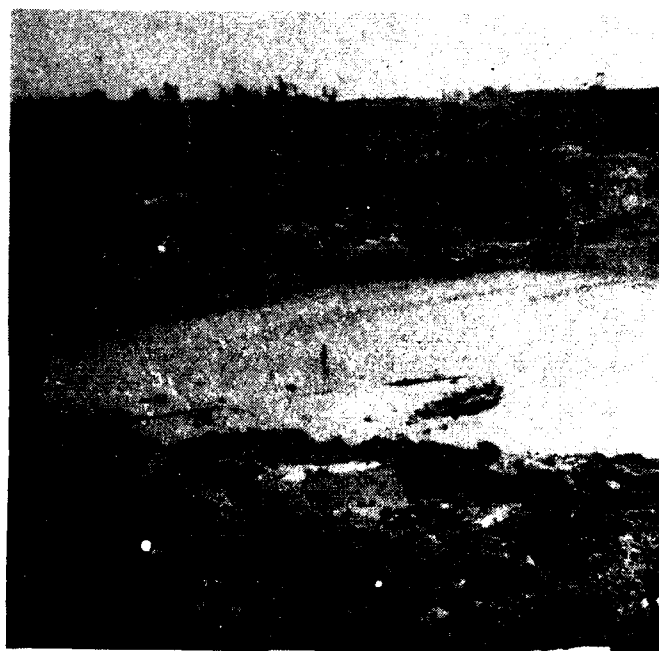
Photo 19 - Looking west into west retaining wall foundation area - near horizontal wall seam is at El. 307 (September 1978)

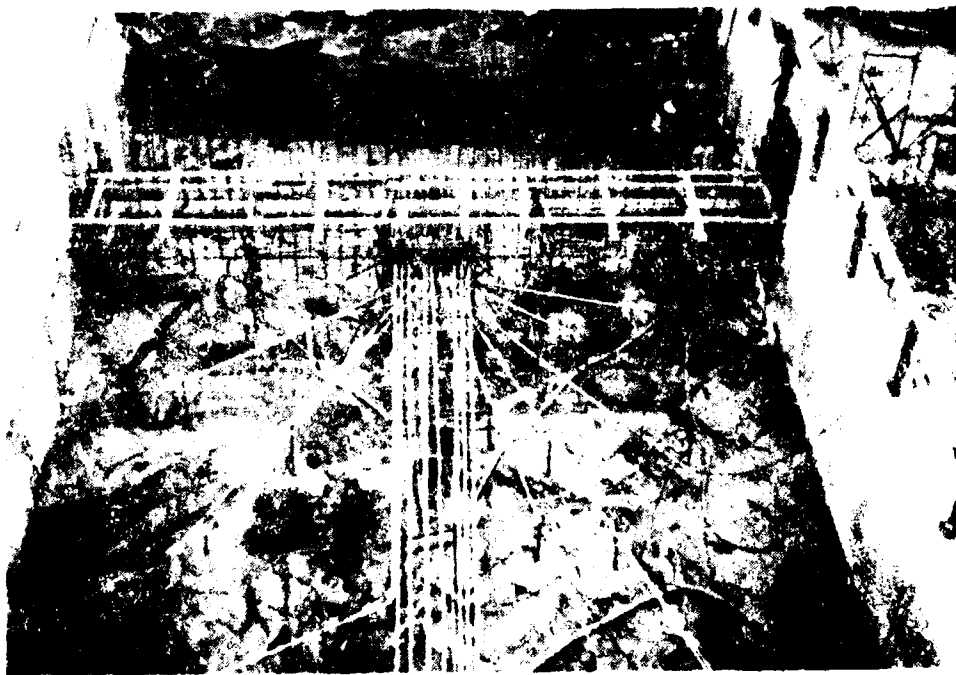
Photo 3 - Leak in rawwatering pipe - Monolith 1. (November 1979)

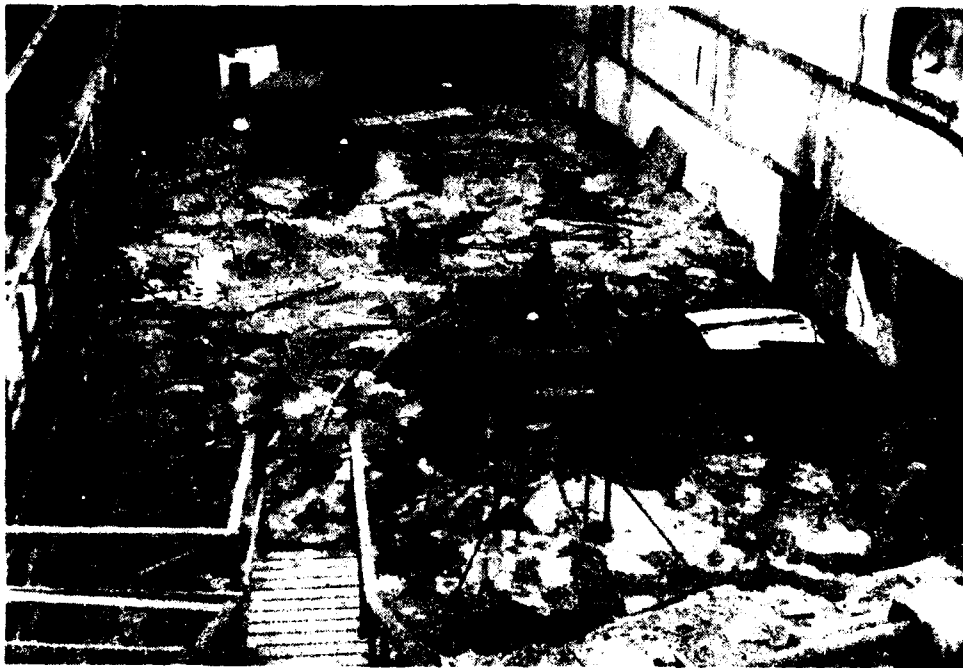
Photo 56 - Foundation of the dike that contains rounded cobbles of felsic rock. At least one of these cobbles had an apparent bedded structure which had survived contact metamorphism and recrystallization. (March 1979)

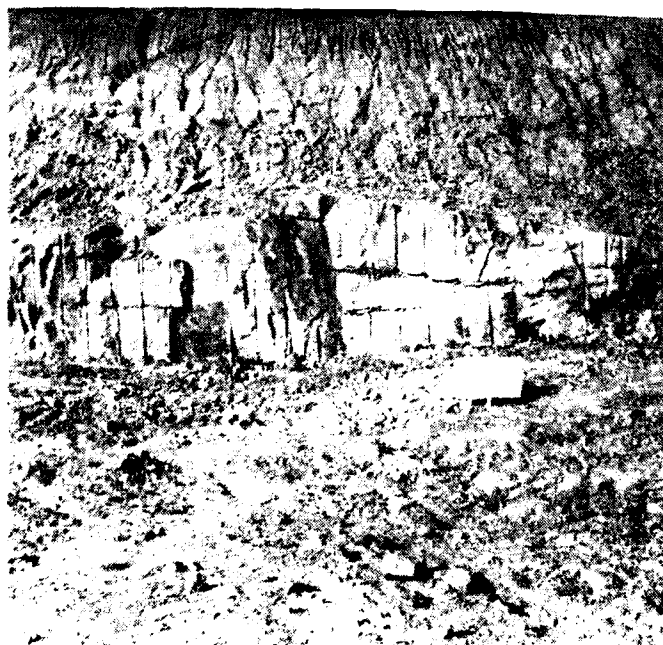
Photo 15a - Excavation of broken material in Moonlith 5 near joint with Moonlith 4. Material has not been blasted (September 1978).

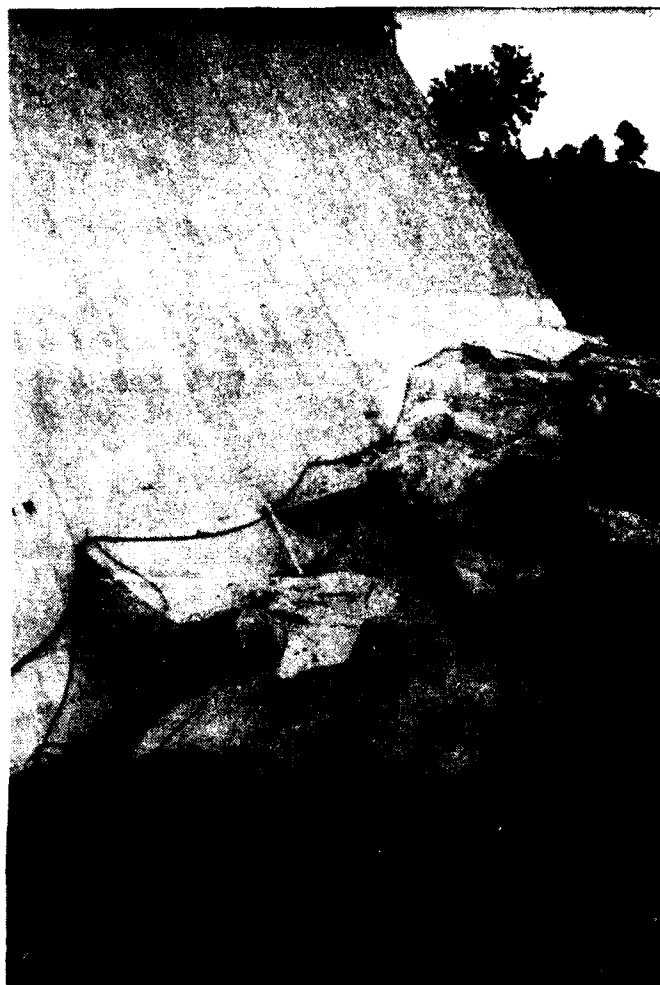
Photo 189 - Drill water leaks from rock downstream of dam centerline near 30/31 Monolith joint. Communication with grout hole 18+03 was observed in this area (August 1981)
